Original Research Paper

Fluvial Processes and Channel Stability of the Torsa River, West Bengal (India)

Fluvial processes such as bank erosion plays an important role to change the channel stability of the Torsa River in the downstream region. The present study was focused on stream stability assessment of the Torsa River. The study area is situated between the downstream of the Jaldapara Reserve Forest and confluence of Kaljani River. Data of different parameters about 64 bank segments of the Torsa River were prepared using the field work techniques for assessing the stream bank conditions using lateral, vertical and overall reach stability models. The individual results of BEHI and NBS ratings show that out of 64 bank segments only 35 and 19 bank segments classified in higher categories. Overall lateral stability analysis shows that most of the sample bank segments are in an unstable condition. All bank segments are vertically unstable and degrading. Overall reach stability analysis shows widespread instability. BEHI and NBS results are almost similar for most of the bank segments and therefore, BEHI and NBS can be suitable bank erosion hazard predictive models in the study for

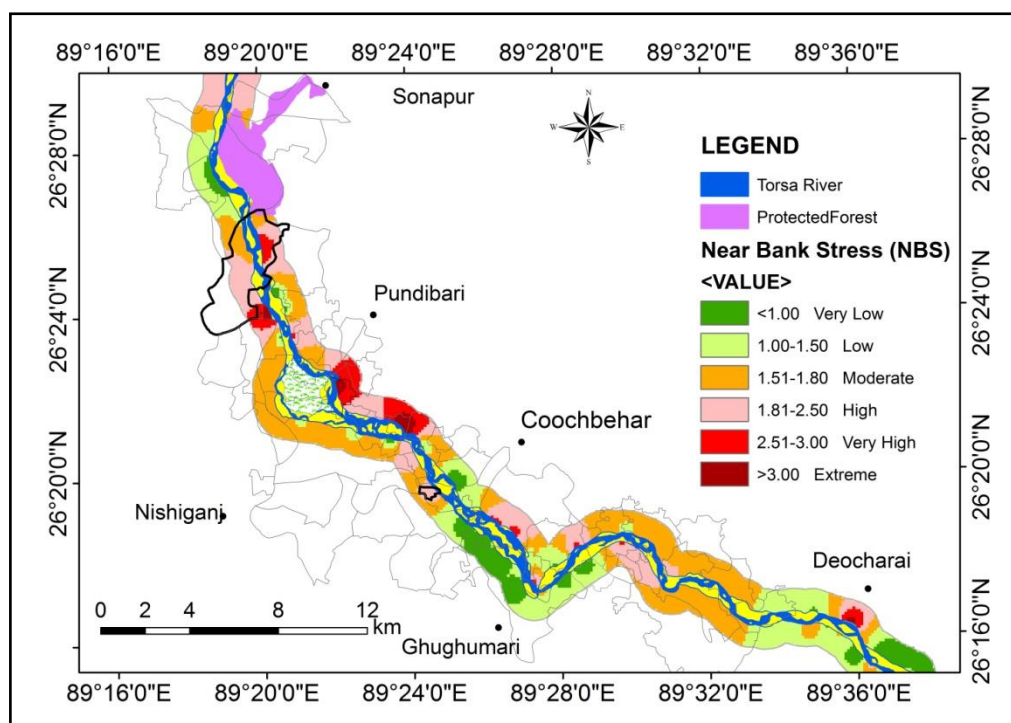
Figure 5. Near bank stress rating zones

River bank erosion is accelerated due to changes of Near Bank Stress (NBS) ratings (Rosgen, 2001a; Ghosh *et al.*, 2016). Based on the field generated data, final NBS rating and rating zone have been determined to assist bank erosion vulnerability (Table 4; Figure 5). Most of the bank segments having high (19 segments) ratio of near bank maximum depth to the bank-full mean depth. On the other hand, 18 bank segments having the ratio of the near bank maximum depth of the bank-full mean depth is low (Table 4). Results show that Basdaha Natibari, Salmara Tritiakhanda, Hariipur, Madhupur, Jatrapur and Deocharai villages are very high to extremely vulnerable to bank erosion (Figure 5). The rest of the bank segment is very low to moderate vulnerability to erosion due to presence of riparian

vegetation and anthropogenic constructions; such constructions are controlling the bank erosion (Figure 5).

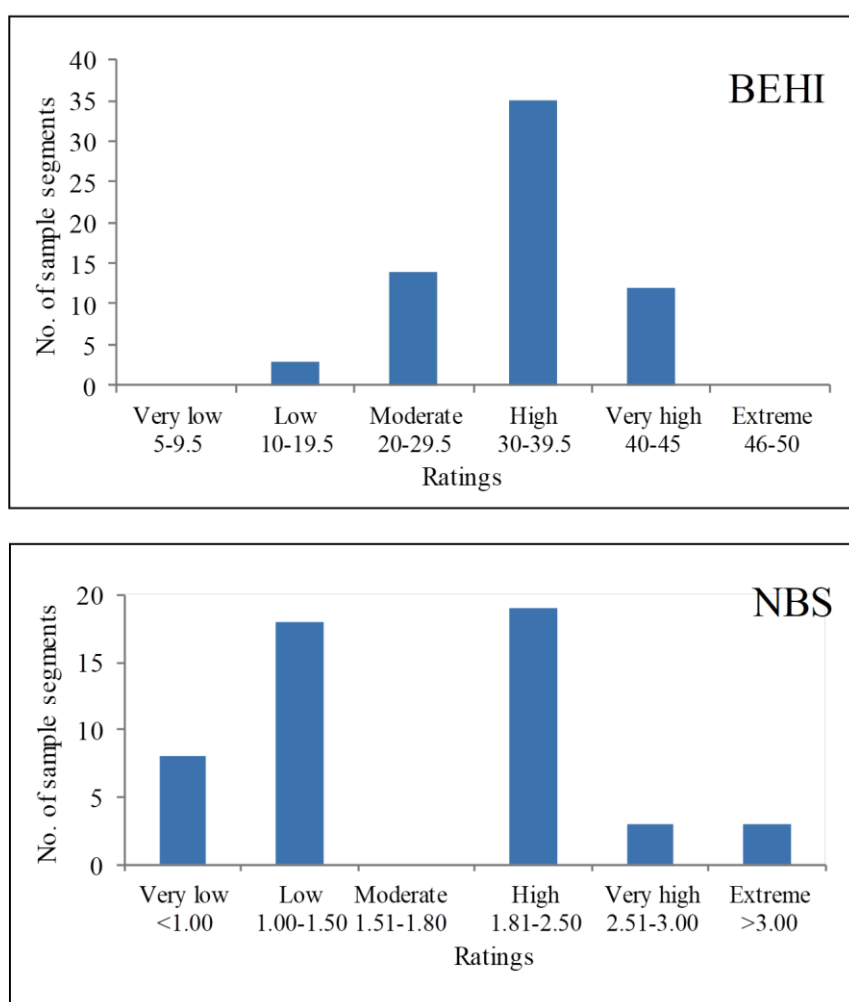
Figure 6. BEHI and NBS distributions

The individual BEHI and NBS ratings have been plotted in Figure 6 from where 35 bank segments indicate high BEHI ratings, 12 segments experience very high BEHI ratings, 14 bank segments belong to moderate BEHI ratings and 3 segments possesses low BEHI ratings (Figure 6; Table 5). On the other hand, out of 64 bank segments only 19 segments possess high category NBS rating, 18 segments indicates the low NBS rating, 8 segments indicate a very low NBS category, 3 segments possess very high category NBS ratings and 3 segments possess extreme category NBS ratings (Figure 6; Table 5).

Correlation between BEHI and NBS ratings along the left and right bank show that the positive correlation, 0.220 and 0.245, respectively. But most of the sample segments as per BEHI ratings are more vulnerable (47 sample segments) to bank erosion than the NBS (25 sample segments) ratings (Figure 6). Out of 64 bank sample segments only 14 segments are perfectly matched with each other. 24 sample segments which are not matched with each other (Table 5). Result of overall lateral stability category shows that the most of the sample bank segments are in unstable condition (Table 5). Torsa River is stabilized along the left bank side due to the presence of dense protected forest and construction of embankment.

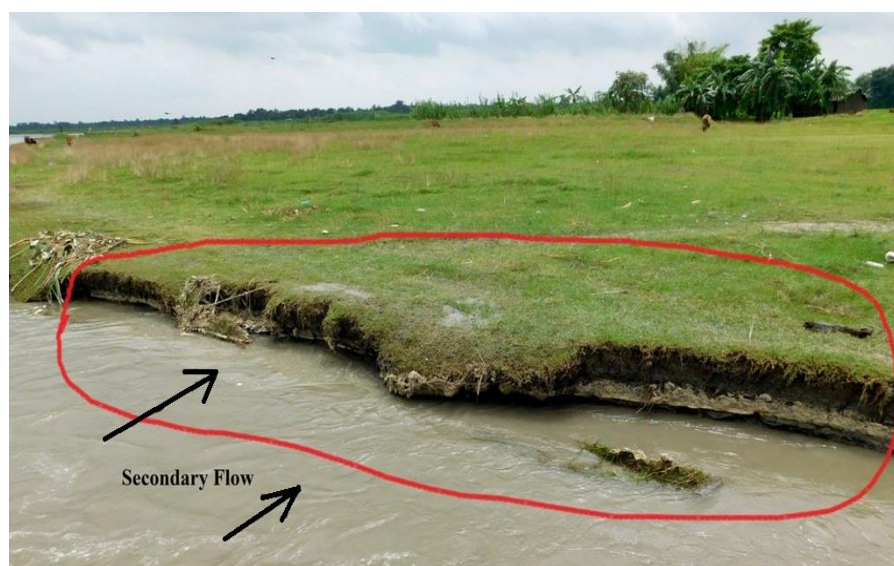
Figure 7. Mechanism of secondary flow to generate bank erosion

BEHI and NBS models, the bank erosion vulnerability study has been made by field verification to estimate the accuracy level. All the data have been derived during the peak monsoon season with the help of GPS survey (Table 8). All the bank segments are found to be more or less unstable condition during monsoon season due to generation of helical flow as well as secondary flow (Figure 7). Primary flow directly attacks the outer bend and secondary flow directly hits at the base of the bank (Figure 7). As a result, the bank materials are removed

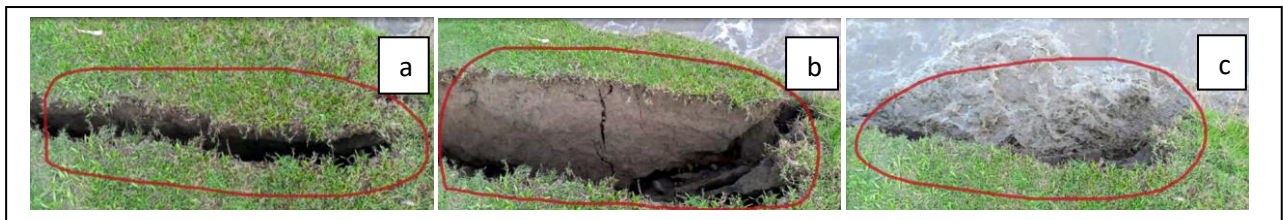
Figure 8. Stages of removal bank material and toppling process

from the base. After removal of the basal support, the bank top is collapsed due to gravitational force and this material are gradually washed away (Figure 8) by steady flow (Maiti, 2016). This type of erosion process is frequently observed in the Torsa river reach. Within a very short span of time, hectares of land regularly erode during monsoon season due to these processes (Table 8). Results of lateral, vertical and overall reach stability show that the stability of the Torsa river reach is widespread unstable in nature (Table 5, 6 and 7). Finally, the stability model has completely been validated with field verification.
